PROVIN MOUNTAIN RESERVOIR

MA 00528

PHASE I INSPECTION REPORT NATIONAL DAM INSPECTION PROGRAM

JUNE 1981

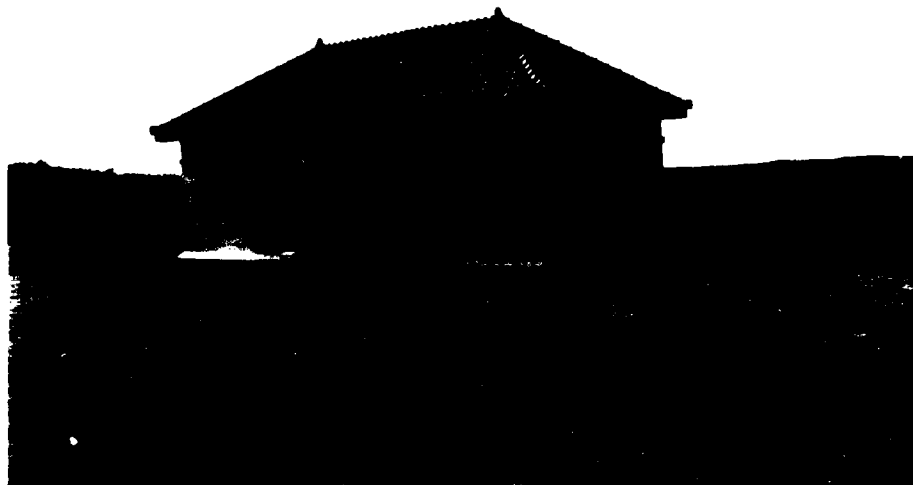
This structure consists of concrete masonry unit walls with a concrete floor and tiled roof (see Photo No's 3 and 4). The structure is in good condition.

PHOTO NO. 3
FRONT VIEW OF INLET GATE HOUSE

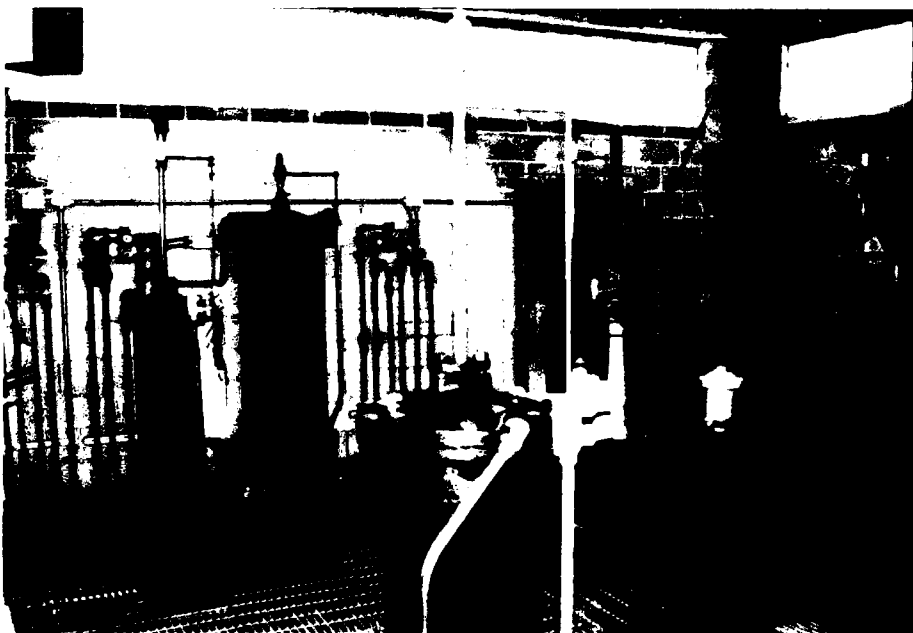
The building houses two hand crank operated bench stands manufactured by the Chapman Valve Mfg. Co. Both gates were opened by approximately 48-inches. The bench stands and stems are well maintained and in good operating condition.

The structure also houses eight additional gates and a compressor for operation of the aeration system. This system appears to be in good condition.

PHOTO NO. 6
VIEW INSIDE AERATOR CONTROL HOUSE

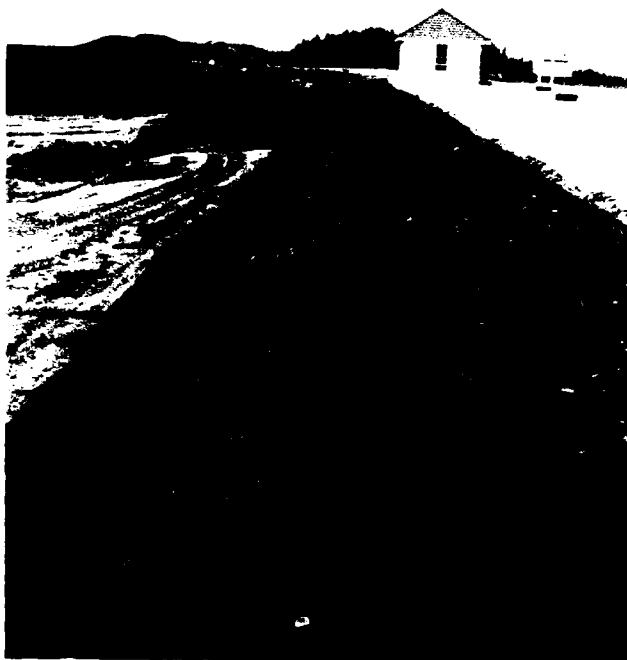
PHOTO NO. 9
VIEW OF WEST EMBANKMENT
LOOKING NORTH

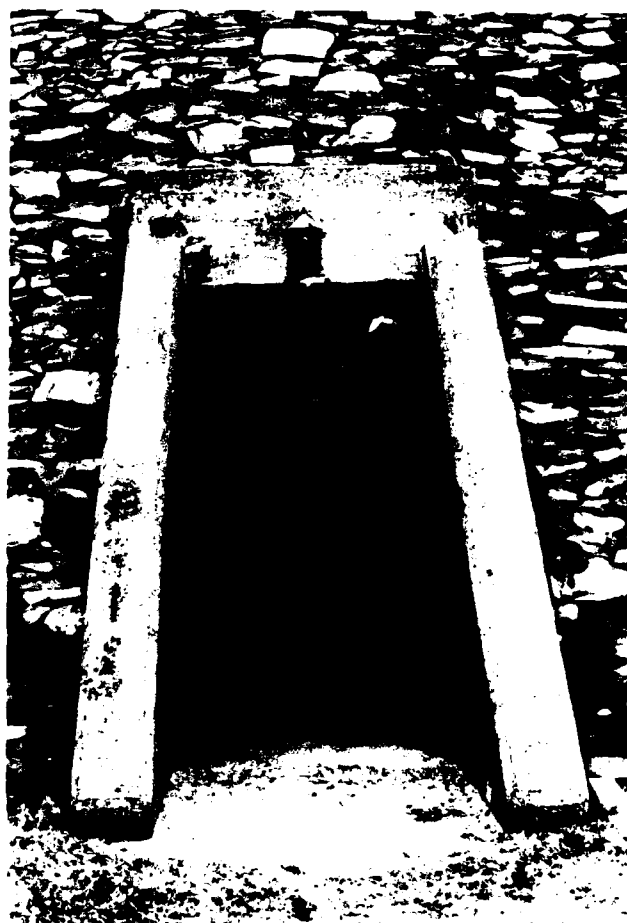
PHOTO NO. 10
VIEW OF ACCESS DOOR TO RESERVOIRS
NO. 1 & NO. 2 ON WEST EMBANKMENT
